PROFESSIONAL RESERVE STUDY

Tamarack Village

10701 to 10798 - 221st Lane NE, Redmond, WA 98053

February 7, 2017

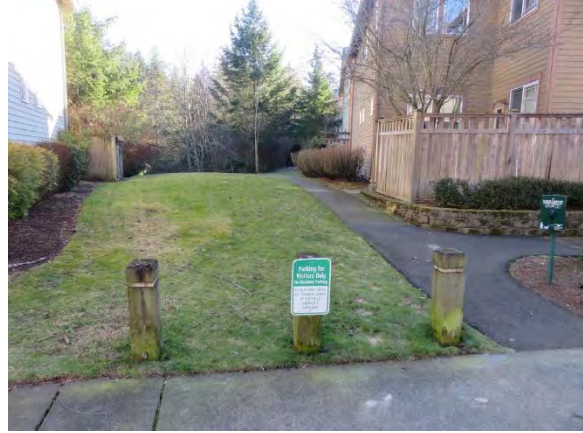
There is an asphalt walking path leading to the pond. We have budgeted for periodic repairs of this asphalt walking path, which we understand was last repaired in 2015.

Asphalt Path was Repaired in 2015

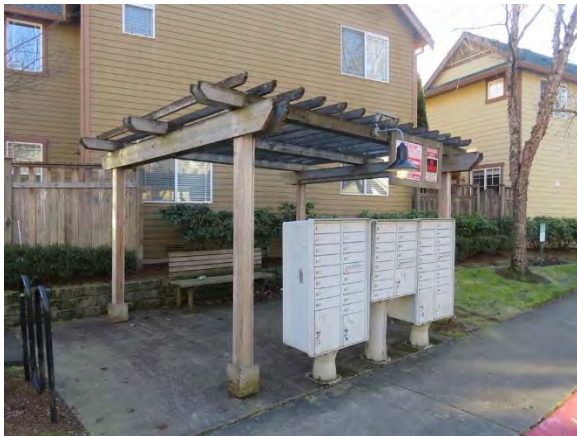
There is one wood mailbox trellis and three mailbox kiosks on this property. We have assumed that the wood trellis will be stained and have spot wood replacement every 3 years. These metal mailbox kiosks should have a total lifespan of 25 years prior to replacement.

Mailbox Kiosk and Three Metal Mailbox Kiosks

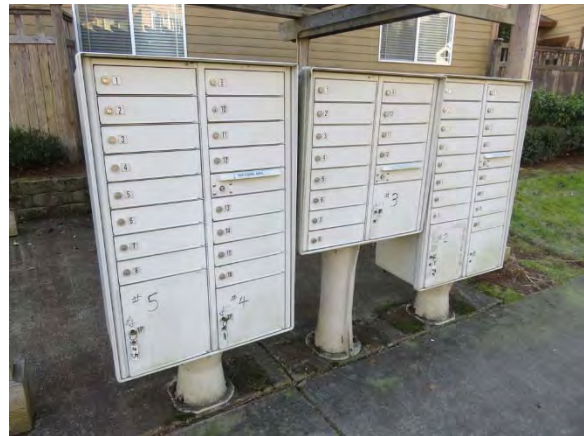
Three Metal Mailbox Kiosks

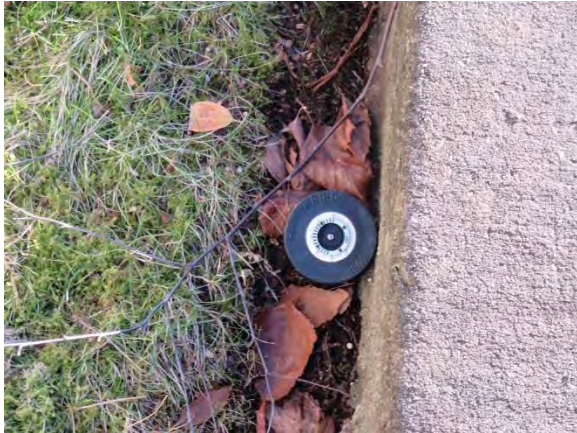
There will be a large one-time irrigation repair expenditure in 2017 of approximately \$10,000. Going forward, we have assumed that the irrigation system will be maintained as necessary via routine maintenance.

Typical Irrigation Sprinkler

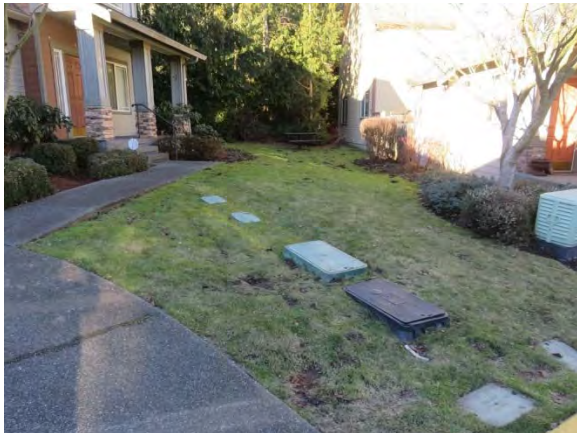
We understand that there is a significant mole problem in the vicinity of the picnic table. This is an appropriate use of funds dedicated to a landscaping allotment.

Common Lot with a Mole Problem

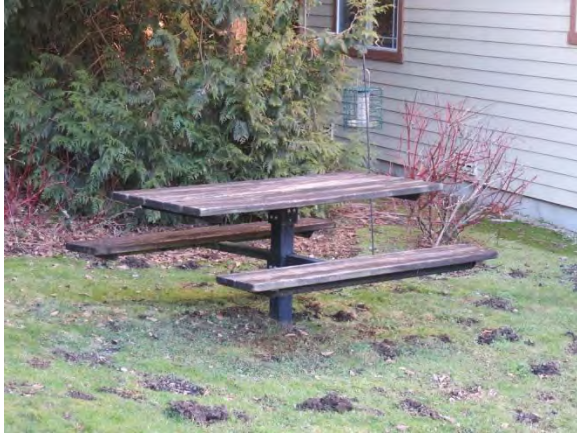
There is one common picnic table, two common benches along the shore of the retention pond, and two benches beneath the central trellis. We understand that the benches along the retention pond were recently replaced. We estimate that the picnic table and the trellis benches will need to be replaced in 2020. We assume that these benches and the picnic table will have a total lifespan of 20 years.

Picnic Table

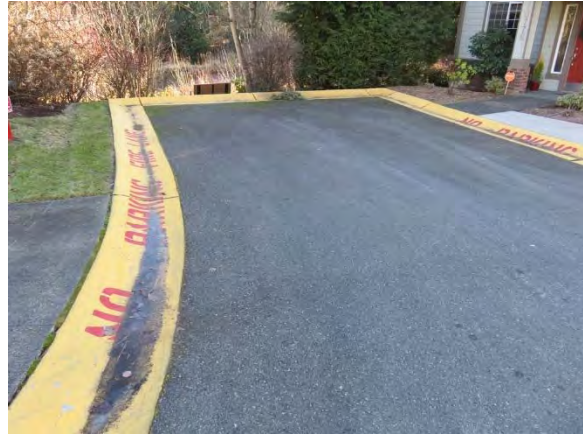
We understand that the curbs were restriped in 2013. We understand that the Board plans to restripe the sidewalks every 8 years, which we have budgeted for in this study.

Typical Extruded Concrete Curb

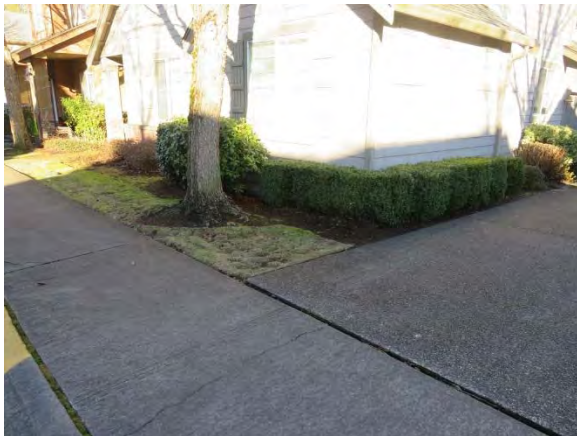
There is a typical amount of settlement in the concrete sidewalks and driveways, and a certain amount of broken concrete curbing. Therefore, we have budgeted for a concrete repairs every 2 years.

Typical Sidewalk and Driveway Trip Hazard

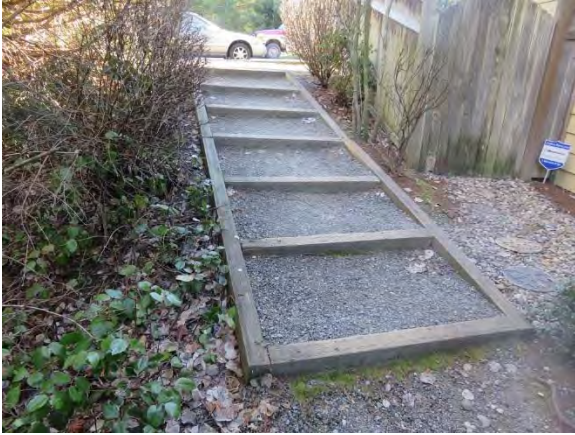
There are wood steps at the end of the walking path adjacent the street. We have budgeted for these wood steps to be replaced every 15 years.

Wood Steps at End of Walking Path

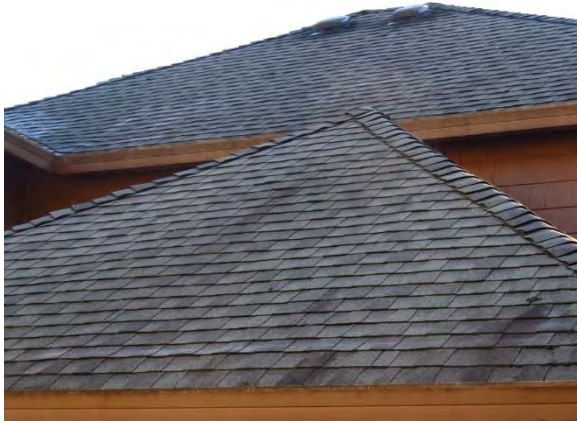
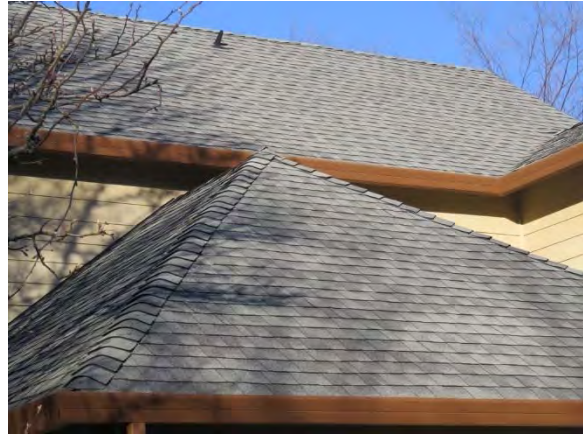
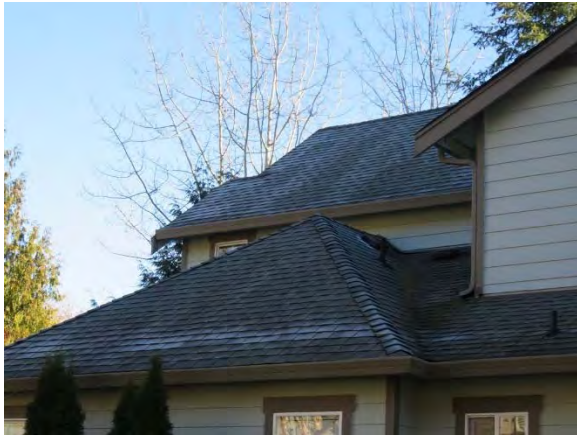
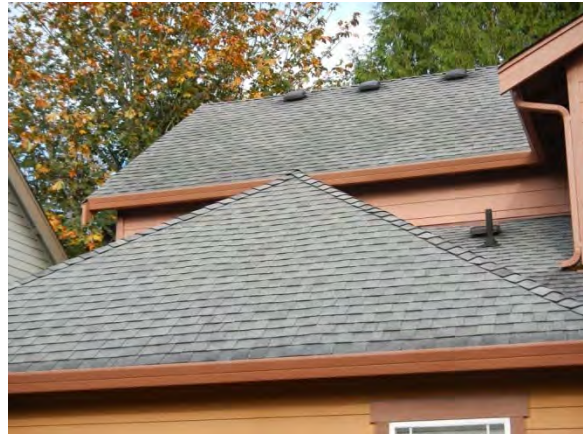
The roofs of these buildings are pitched and are surfaced with asphalt composition roof surfacing. This roof surface is a laminate 30-year architectural composition product. We understand that this is the original roof surface to these buildings that were built in 2000.

Typical Roof Surface

We understand that each individual homeowner is responsible for paying for the roof resurfacing and gutter replacement of their own buildings. No reserve funding has been allotted for roof resurfacing or gutter replacement.

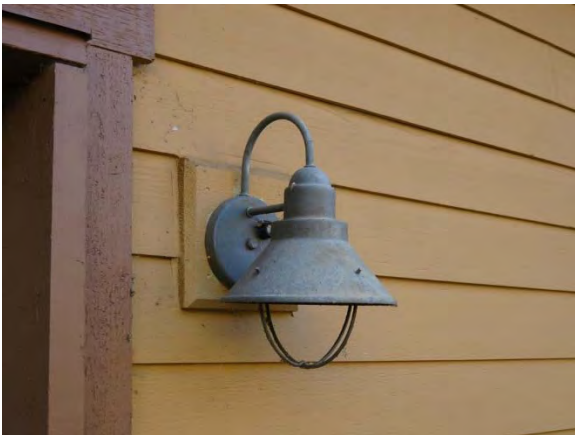
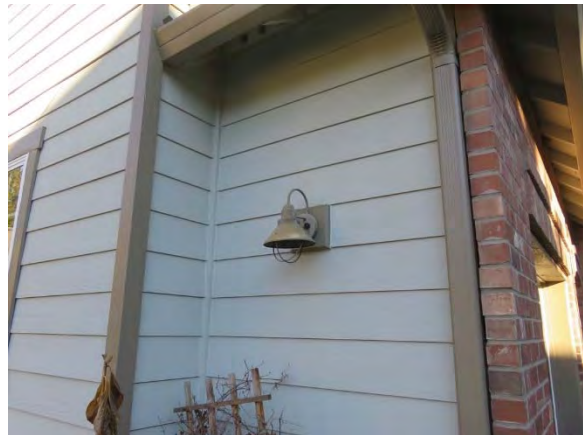
The exterior light fixtures consist of one building mounted light at the front of each individual unit and one building mounted light above the doors at the rear of each individual unit. We have scheduled these lights to be replaced on a 20 year cycle. We understand that the Board plans on ultimately replacing all of these lights at the same time to maintain a consistent aesthetic and ensuring adequate function to maintain proper lighting of the development.

Typical Exterior Light

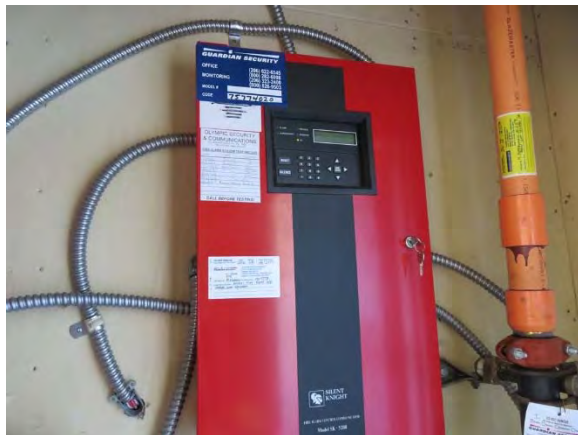
Each building has a central fire alarm system. These systems appear to be maintained by Guardian Security. We have assumed that this system will be updated every 25 years with replacement of the fire alarm control panels, per the recommendation of NFPA.

Typical Fire Alarm Panel

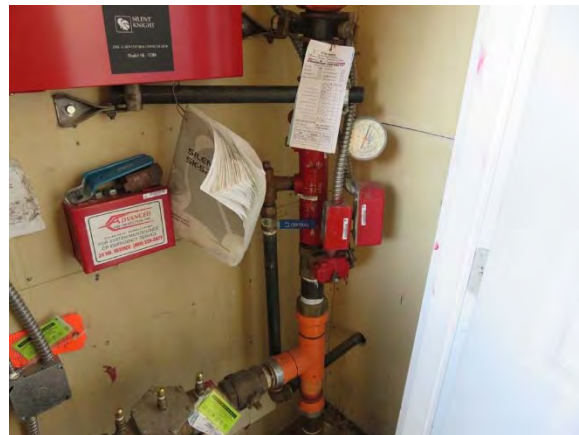
Each building has a fire suppression system that is also maintained by Guardian Security. This supply lines for this system are primarily CPVC piping. We have assumed that all general maintenance of this system will be provided by Guardian Security as a part of their service contract.

Typical Fire Suppression Piping, Meter, and Valves

We understand that fire suppression confidence testing will be performed in 2017 and every 10 years thereafter. We have budgeted \$2,500 for this confidence testing. There may be repairs that will be necessary that come to light from this confidence testing; however, any potential mediation is unknown and has not been budgeted for at this time.
